April 27, 2023

Re: Indoor Air Quality Testing
SAU 26; Office Building Basement
RPF File 230073

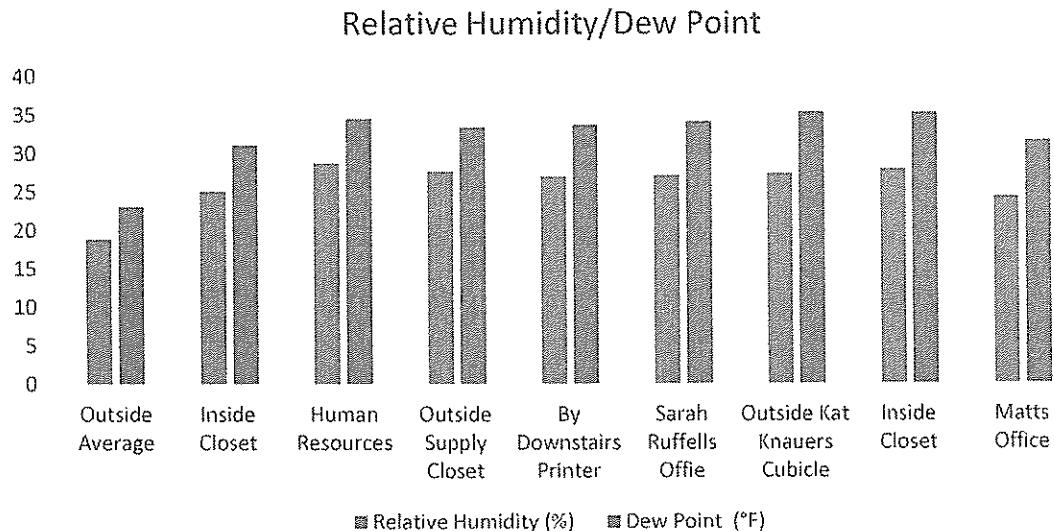
Temperature will affect the occupant's perception of IAQ based on employee comfort levels, effect of drafts or airflow, and humidity levels in a building. In most cases, simple adjustments to thermostats and direction of airflow from registers can improve perceived IAQ. As a reference, the temperatures recommended by ASHRAE for general office space ranges from approximately 68° to 75° Fahrenheit in the winter, and from approximately 75° to 80° Fahrenheit in the summer. Temperature readings at all indoor locations tested were documented in the range of 72° to 75.2° Fahrenheit.

The amount of water vapor that can be contained in the air varies by the temperature and pressure of the air. The ratio of water vapor in the air to the maximum amount of water vapor the air can hold at a given temperature is expressed as relative humidity (RH). The recommended RH comfort range is 35% to 55%. In general, for buildings, the presence of excessive moisture can lead to mold growth and other biological contaminants. Low RH, common for buildings in New England during colder months, may contribute to irritated mucous membranes, dry eyes and sinus discomfort while high relative humidity, common in summer, may cause discomfort, as it hinders the body's use of perspiration as a cooling mechanism. RH levels at the indoor locations tested during this survey were below the generally accepted comfort range.

Dew point is related to humidity and is the temperature below which water vapor may start to condense to form water droplets on a surface. If dew forms on interior building materials, the material may become wet, and subsequent fungal growth can occur. For instance, an uninsulated cold-water pipe may form condensation when the temperature of the metal surface is colder than the environmental dew point, and drip onto surfaces causing them to become wet. Dew point measurements on the day of testing ranged from 31.1° to 35.3° Fahrenheit. Based on these results, the interior temperature readings were all above the Dew Point readings. The results and testing locations are presented in Appendix A.

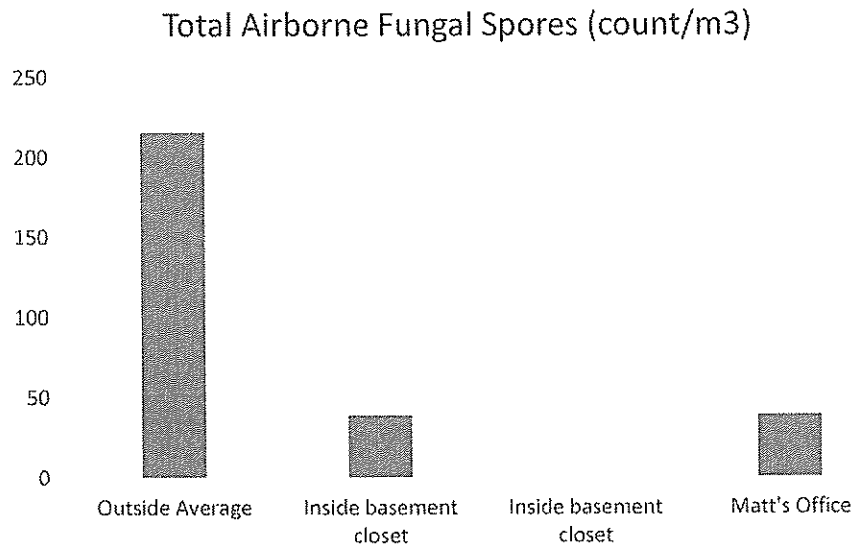
Sample ID	Location	Results
021423-A01 & 021423-A05	Outside Control Samples	Concentrations of Ascospores, Basidiospores, and Cladosporium spores present.
021423-A02	Basement, inside of closet	Similar concentrations of Cladosporium spores when compared to the outside controls.
021423-A03	Basement, inside of closet	No Spores Detected
021423-A04	First floor, Matt's Office	Similar concentrations of Ascospores spores when compared to the outside controls.

The concentration of total airborne fungal spores in each indoor sample was less than the concentration of total airborne fungal spores in the outdoor control samples. In addition, all individual types of spores detected were consistent with those outside and at lower concentrations than outside. RPF recommends HEPA vacuuming as part of routine maintenance to reduce indoor spores and to reduce dust in general. Many spores are carried indoors from the outdoors where we know spores are present.

Continual inspections for water damaged building materials and fungal growth are recommended as part of routine maintenance. RPF recommends removing water damaged building materials which, at any point, were wet for greater than 24 to 72 hours.
