RE: Preliminary Infrared Screening
Special Services Building
RPF Project No. 125049

Preliminary Infrared Building Survey

SAU 26 Support Services Building

Merrimack School District - SAU 26
September 5, 2012

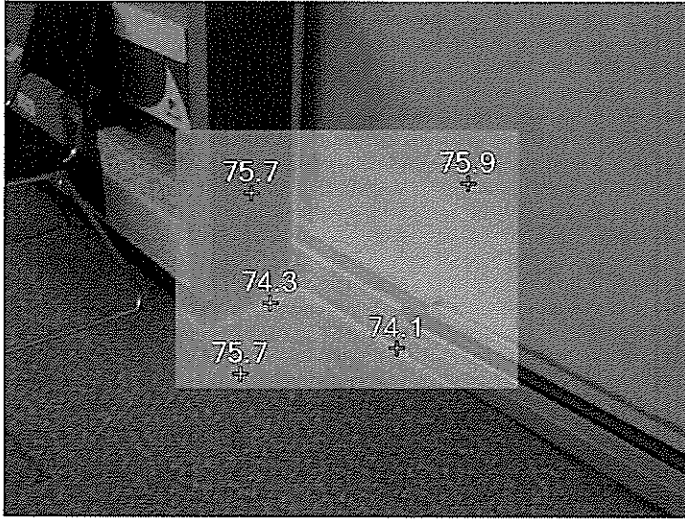
IR20120905_0121.is2

Basement near stairway

Cool areas near edge indicating an area for further investigation.

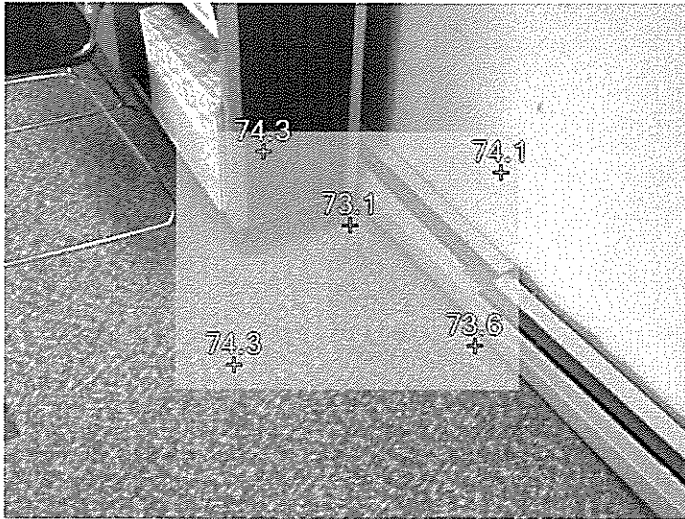
IR20120905_0122.is2

Basement near stair way

Cooler area along edges indicating an area for further investigation

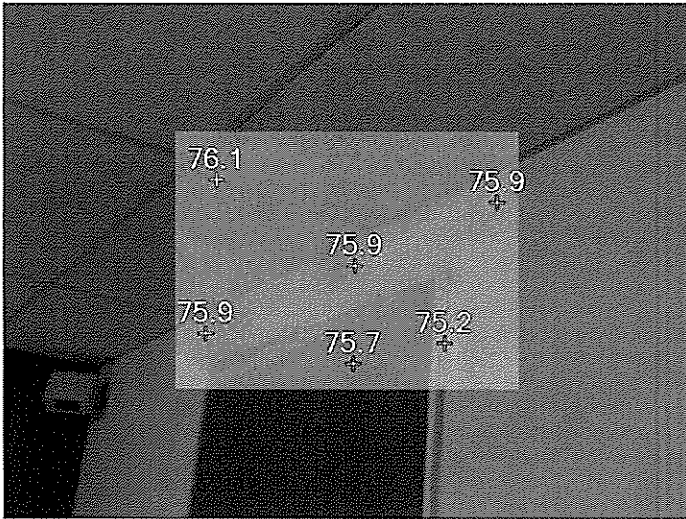
IR20120905_0123.is2

Basement area above door

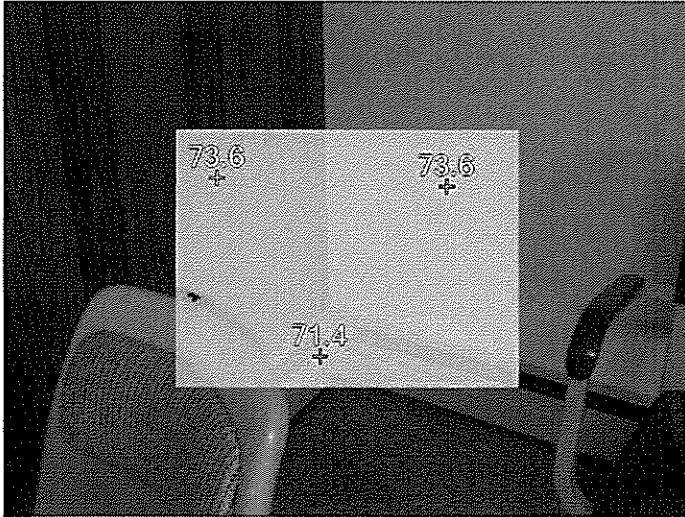
IR20120905_0124.is2

Basement corner with cool spot

Cooler in corner, may be due to water content, lack of insulation or draft, indicating areas for further investigation.

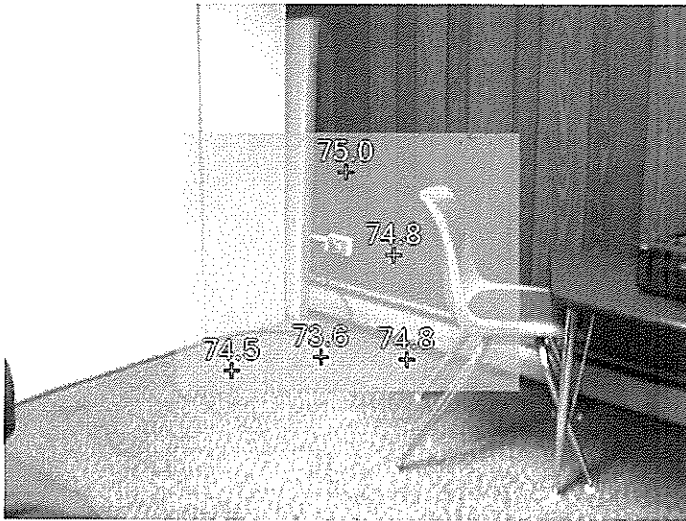
IR20120905_0125.is2

Basement corner

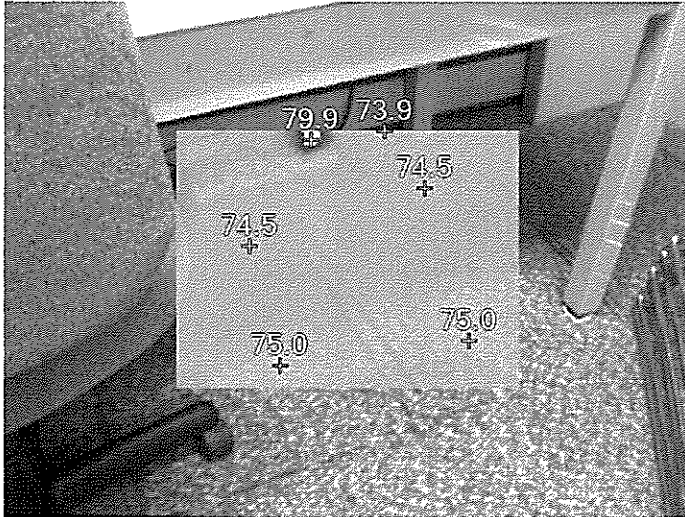
IR20120905_0127.is2

Basement floor under table, hot spot is electrical outlet and cord

Hot spot due to electrical outlet and plug.

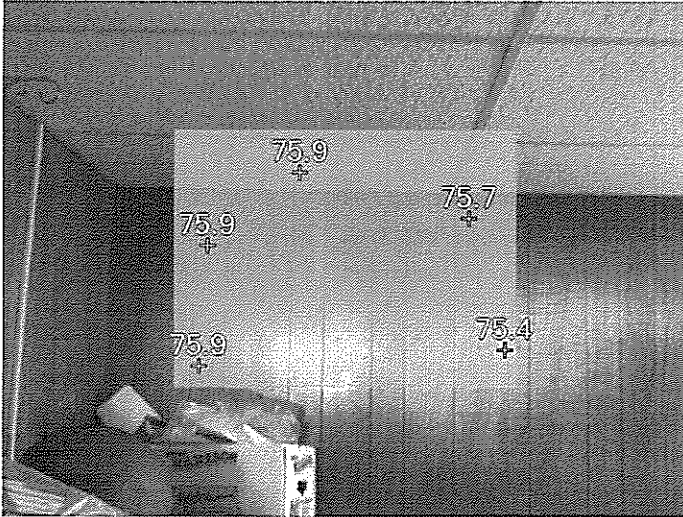
IR20120905_0128.is2

Basement exterior wall near ceiling

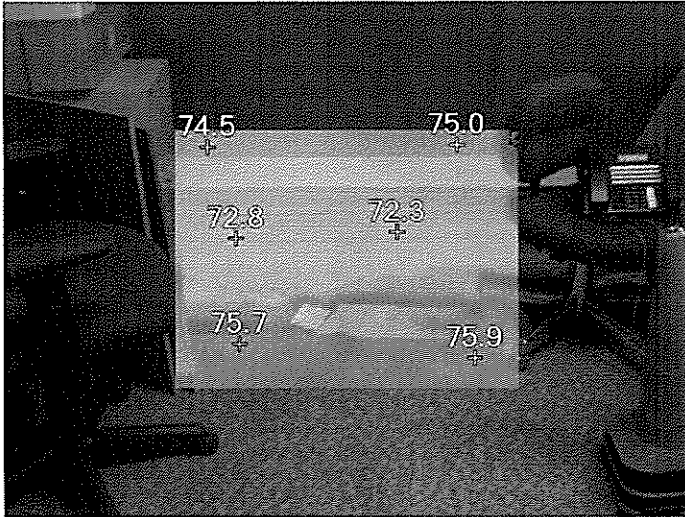
IR20120905_0129.is2

Basement exterior wall under table, end of building

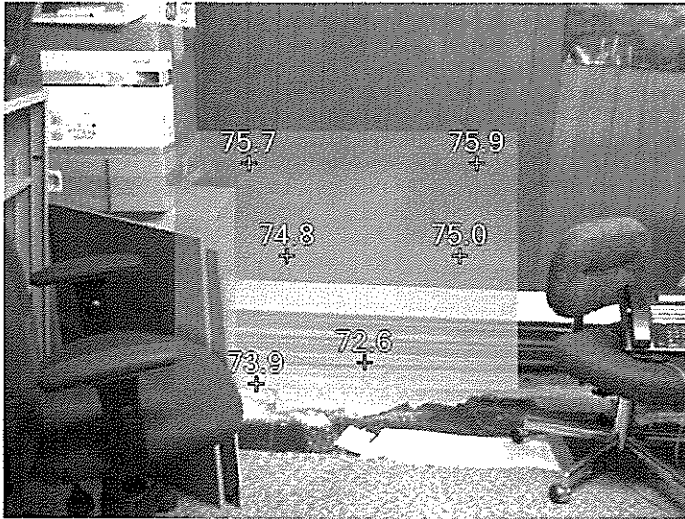
IR20120905_0130.is2

Basement exterior wall in front of stairway

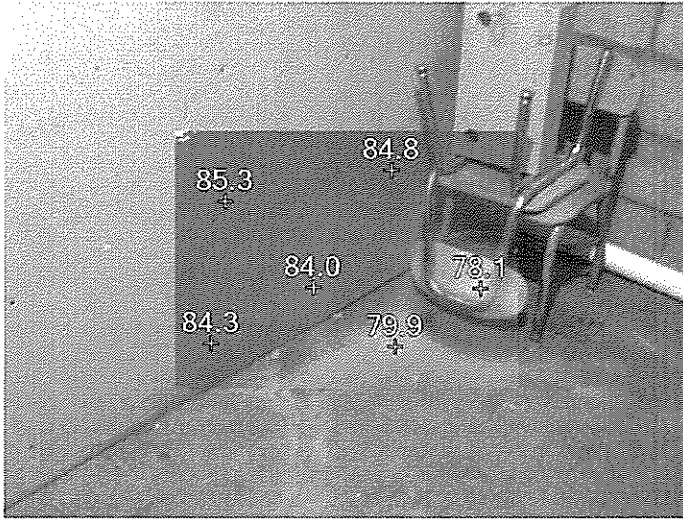
IR20120905_0131.is2

Basement storage room

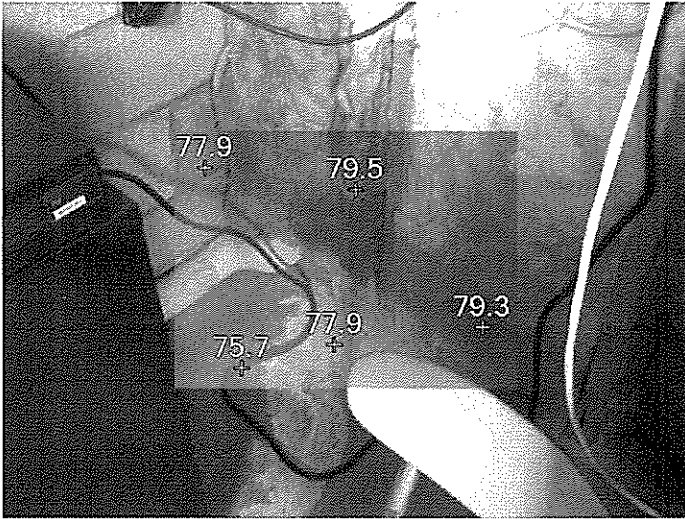
IR20120905_0132.is2

Mechanical room wall - foundation

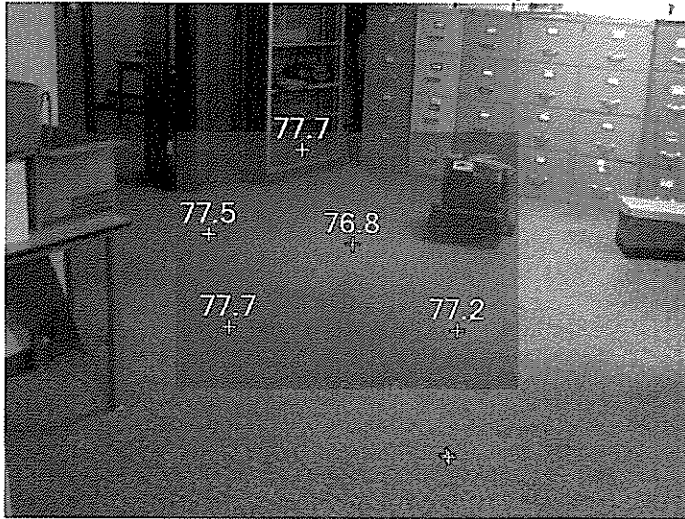
IR20120905_0133.is2

Basement main room floor with carpet

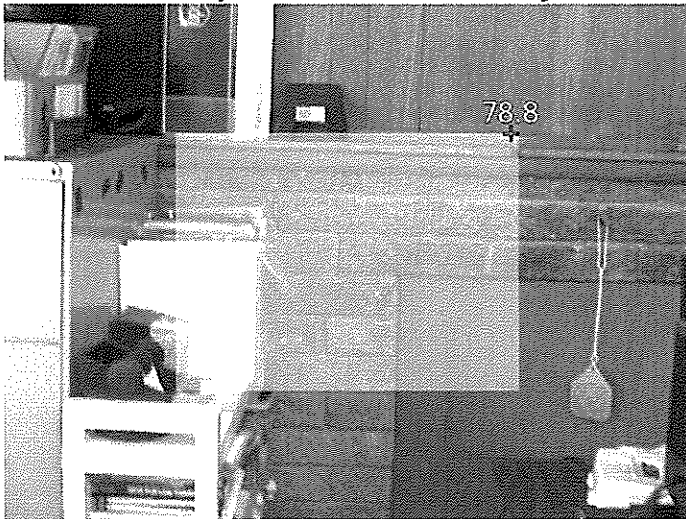
IR20120905_0134.is2

First Floor Fireplace crack in masonry

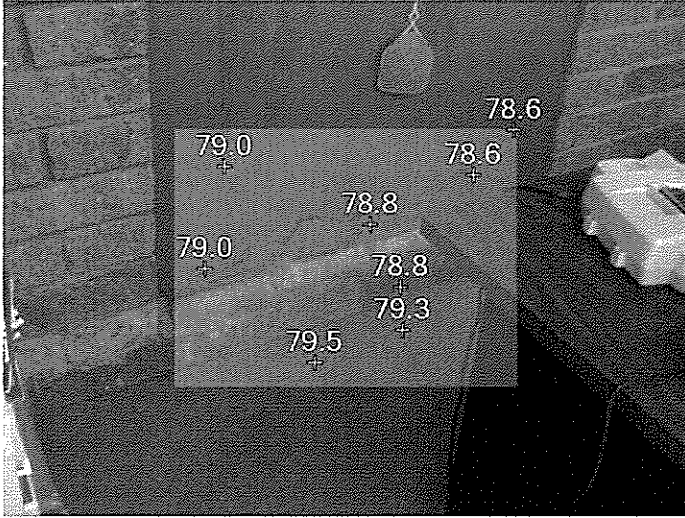
IR20120905_0135.is2

First Floor Fireplace with water staining

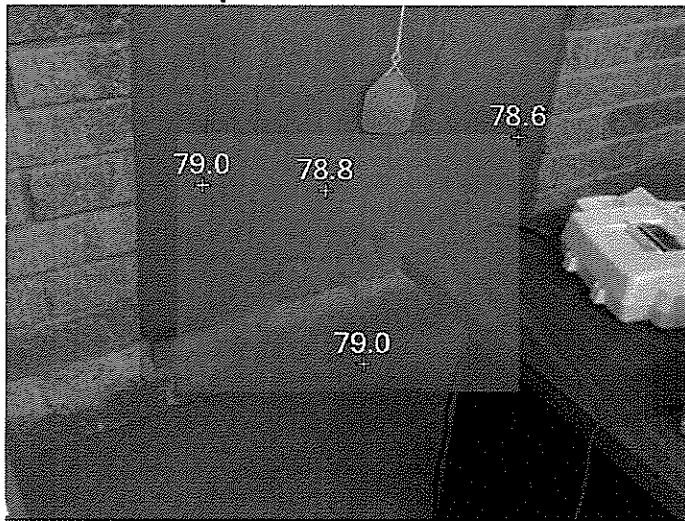
IR20120905_0136.is2

First Floor Fireplace area with water stained board
