Re: Indoor Air Quality Testing
Special Services Building - 2 Brentwood Drive, Merrimack, NH
RPF File 240256

In accordance with our scope of work dated June 5, 2024, RPF Environmental (RPF) completed indoor air quality (IAQ) testing at the Special Services Building located at 2 Brentwood Drive in Merrimack, NH. As part of this preliminary survey, testing was completed for several common IAQ parameters, as well as sampling for airborne and surface fungal spores, total airborne fiber concentrations, airborne asbestos fibers, and bulk samples for asbestos. The survey was completed on June 6, 2024, by Sean Smith and Sonia Stead.

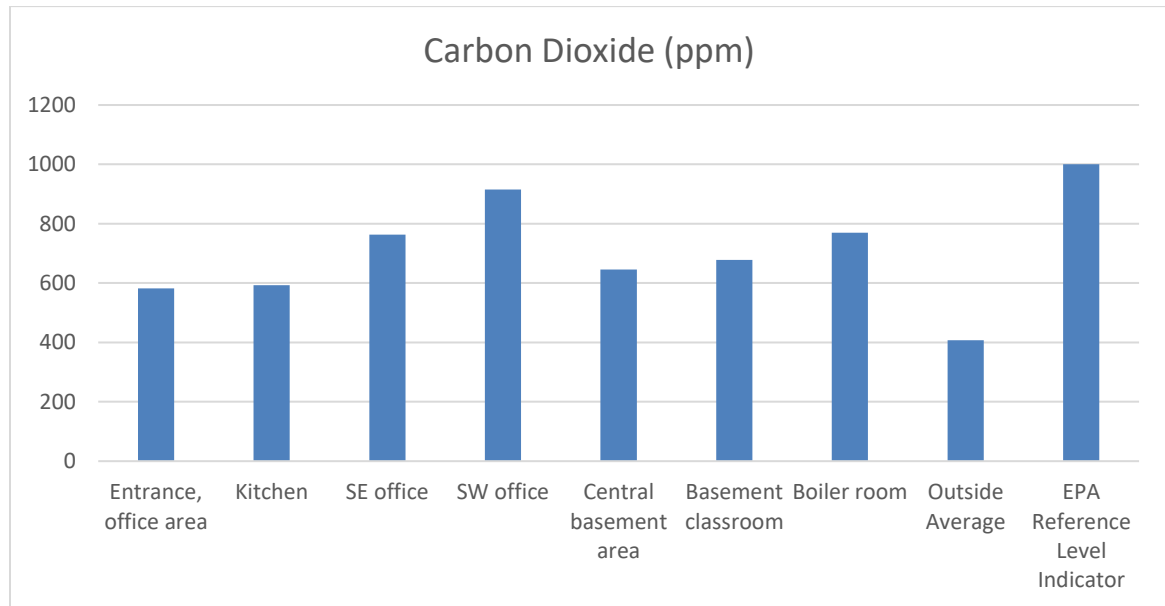
The CO₂ results and testing locations are presented in Appendix A. CO₂ levels at all indoor locations tested were documented in the range of approximately 582 to 915 ppm, which is

well below the Occupational Safety and Health Administration Permissible Exposure Limit (OSHA PEL) of 5,000 ppm. These concentration ranges are also below the generally accepted guideline limit of 800 to 1,000 ppm.

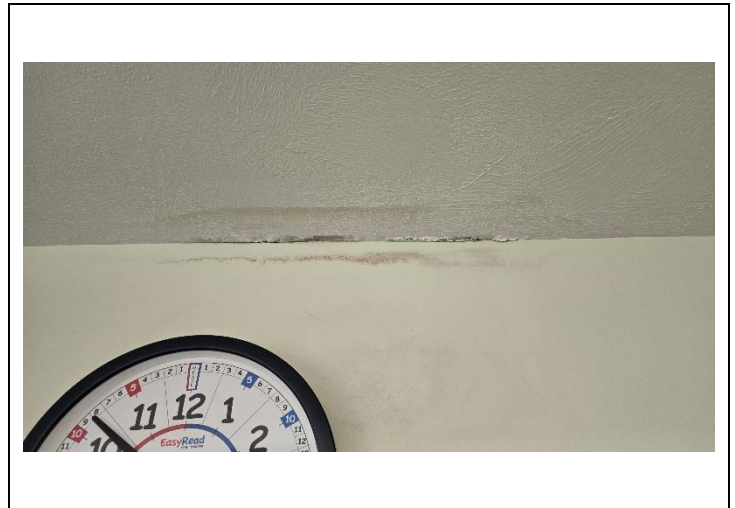
Location	Description
1 st floor, Entrance office area	Water damage observed on the east wall and ceiling.
Basement	Water damaged observed on a section of wall. Suspect growth observed on insulation.

4. Entrance office area water damage area

Continual inspections for water damaged building materials and fungal growth are recommended as part of routine maintenance. RPF recommends removing water damaged building materials which, at any point, were wet for greater than 24 to 72 hours.

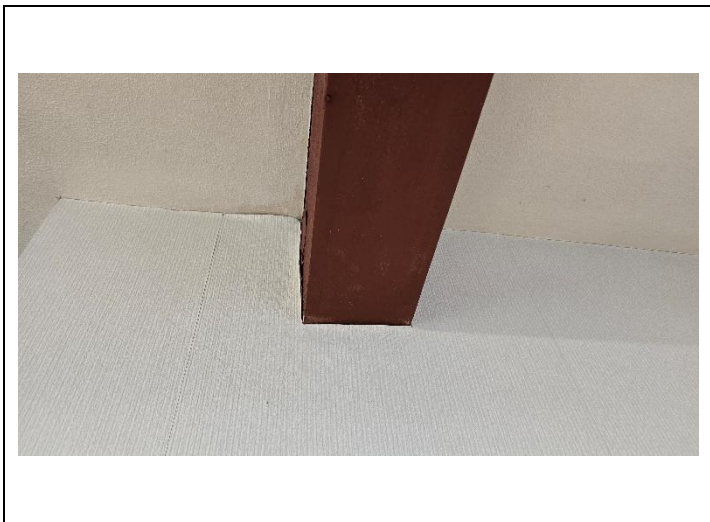
5. View of water staining.

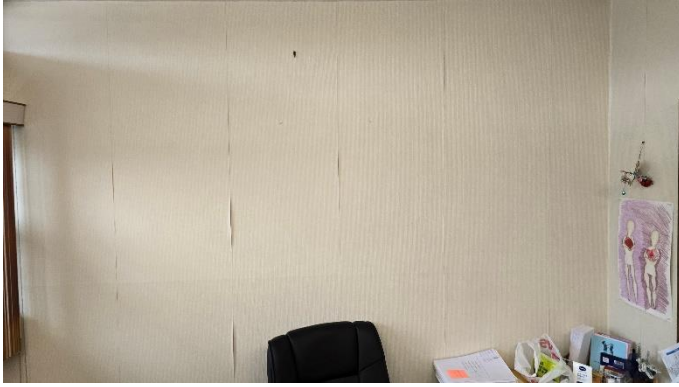
7. View of peeling paint.

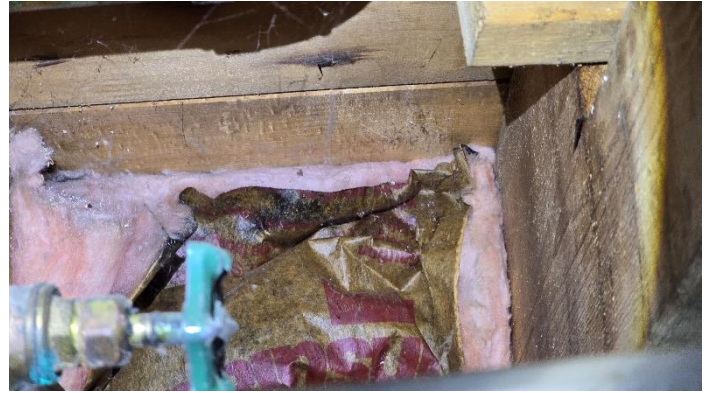
8. Basement insulation with mold

- Visible fungal growth, once identified, should be removed by qualified personnel. There are currently no state or federal standards for the remediation of fungi. RPF references the current New York City Guidelines on Assessment and Remediation of Fungi in Indoor Environments and the Institute of Inspection, Cleaning and Restoration Certification (IIRC) recommended standard, IIRC S520, Standard and Reference Guide for Professional Mold Remediation when preparing work plans. Industry guidelines require that porous building materials which have moisture damage and mold contamination be properly packaged and disposed of by trained personnel with appropriate personal protective equipment (PPE) and engineering controls. Porous materials which are contaminated and left in place can become a reservoir for future fungal growth if exposed to moisture or high levels of humidity. Porous building materials such as carpeting, ceiling tiles, sheetrock and other wall coverings allowed to sit wet for more than 48 to 72 hours typically should be discarded and replaced, as applicable. Non-porous materials may be cleaned, disinfected and thoroughly dried. Work plan development and post remediation verification by a third party industrial hygiene firm, independent from the remediation contractor is also recommended as standard of care.

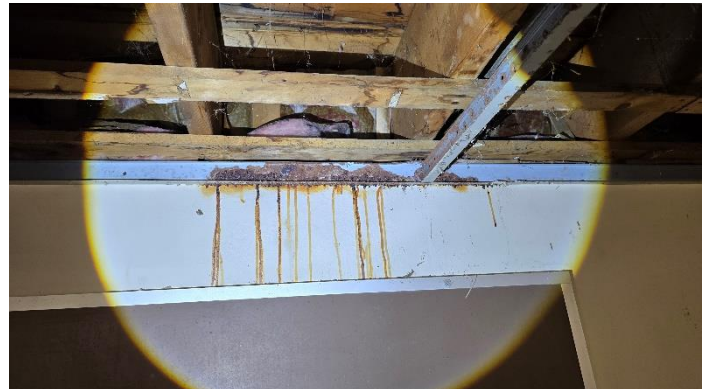
10. More water damage in the basement

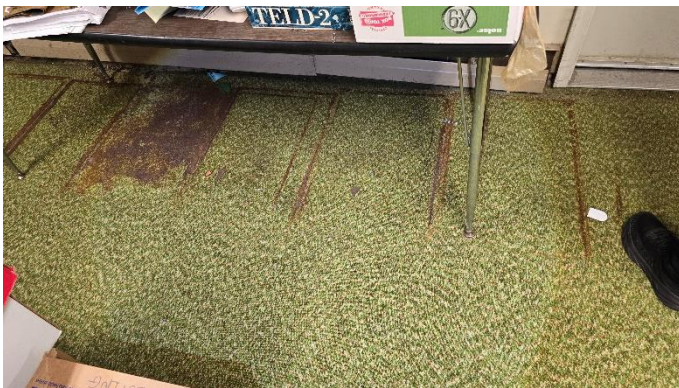
11. Basement main area rug with water damage

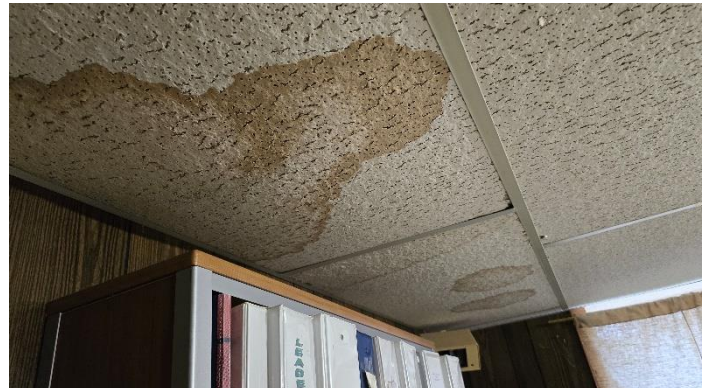
12. Basement main area ceiling water damage

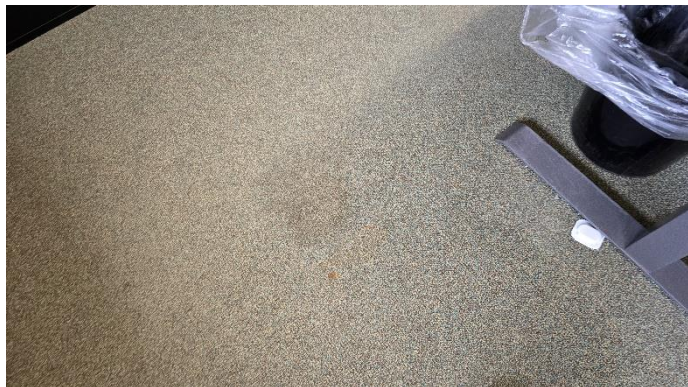
13. Water damage on 1st floor

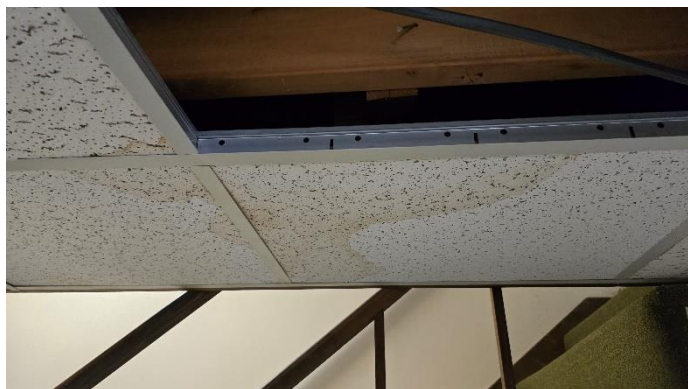
15. Basement ceiling tiles near stair water damage
